The purpose of this letter is to transmit to you EPA's Clean Water Act (CWA) inspection report for the Modern Concepts Inc. facility and to notify you of significant compliance concerns with the Clean Water Act. As you are aware, on February 24, 2016 at 11:30 AM, EPA inspected Modern Concepts, Inc. to determine if the facility is in compliance with the CWA and the requirements of the State of California's *NPDES General Permit for Discharges of Storm Water Associated with Industrial Activities* (Industrial General Permit or IGP, No. CAS000001; Water Quality Order No. 2014-0057-DWQ).

Region 9 Enforcement Division  
75 Hawthorne Street  
San Francisco, CA 94105  
**INSPECTION REPORT**

Inspection Date:	02/24/2016		
Time:	Entry: 11:30 a.m.	Exit: 2:45 p.m.	
Media:	Water		
Regulatory Program:	CWA NPDES/Industrial Storm Water		
Company Name:	Modern Concepts, Inc.		
Facility or Site Name:	Modern Concepts, Inc.		
Facility/Site Physical Location:	3121 East Ana Street		
(city, state, zip code)	Compton, CA 90221		
Geographic Coordinates:	33°51'44.21"N, 118°12'23.16"W		
Weather	Sunny, no clouds		
Facility/Site Contact:	Richard Warpack	President	
	310-637-0013		
County:	Los Angeles County		
Fa

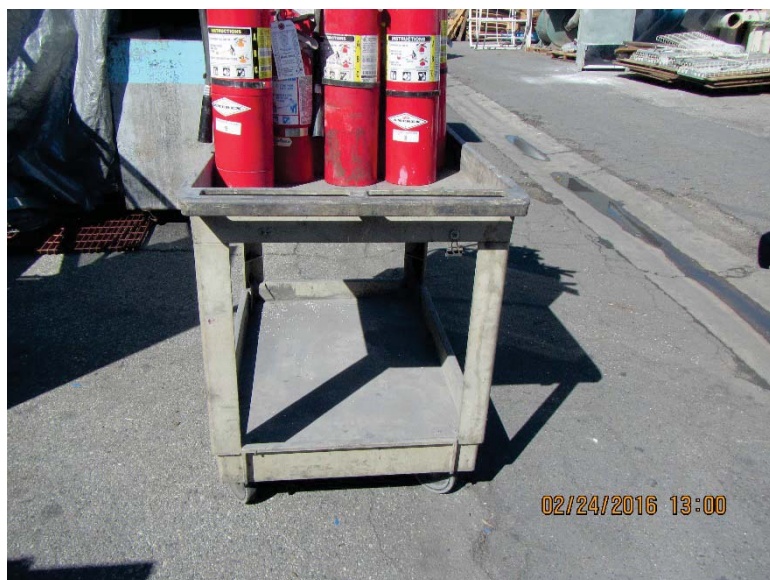
IMG\_0007.JPG. Zoom in of Image 0006 of fire hydrants sitting on 2-level cart. Take note of white plastic pellets on first level of cart.

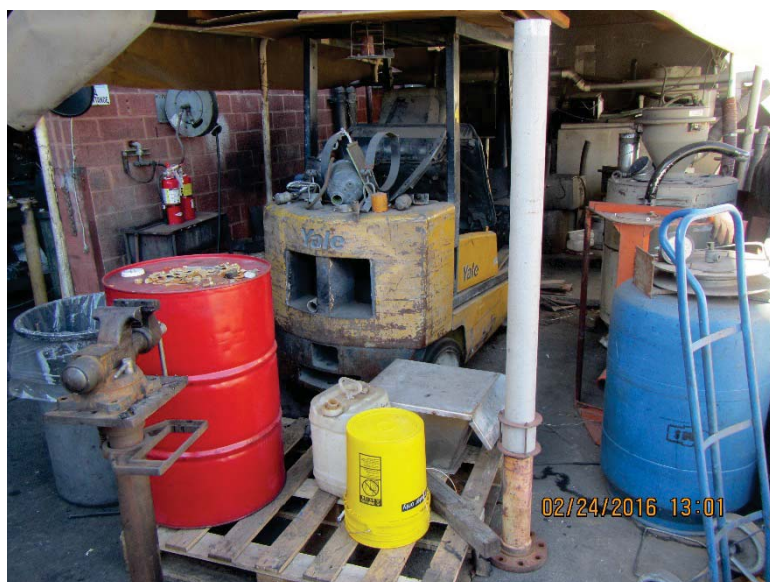
and spill response near the shipping/receiving loading docks. For example, I observed forklift maintenance under a tarp being conducted outside in the parking lot (see Attachment A; Images 008 to 0011) without BMP implementation taking account for impervious surface. I also observed multiple super sacks and storage boxes leaking plastic resin pellets in the parking lot and in the silo storage/backyard area (see Attachment A; Images 0026 – 0031) without necessary secondary containment.

3. I observed that the Facility had not documented a Contingency and Emergency Preparedness Plan at the Facility. SWPPP Section, Spill Prevention and Response Procedures Section 8.4 states “Modern Concepts maintains a current Contingency and Emergency Preparedness Plan in case of hazardous material spill.” Mr. Warpack stated that little to no hazardous material is handled on site that would warrant such a plan; however, Images 0020 illustrated at least 2 barrels of hazardous material stored outside under pallets onsite. Additionally, the facility is registered with the Los Angeles County Fire Department to handle Hazardous material with an assigned CERS ID number 10269547. I observed ongoing forklift maintenance at the Facility. SWPPP Section, Spill Prevention and Response Procedures Section 8.4, states “Vehicles are not serviced at this facility.” See Images 008 - 0011. Mr. Warpack confirmed the forklift was being worked on.

IMG\_0008.JPG. Backside of forklift, adjacent to northeast shipping/receiving dock along parking lot.

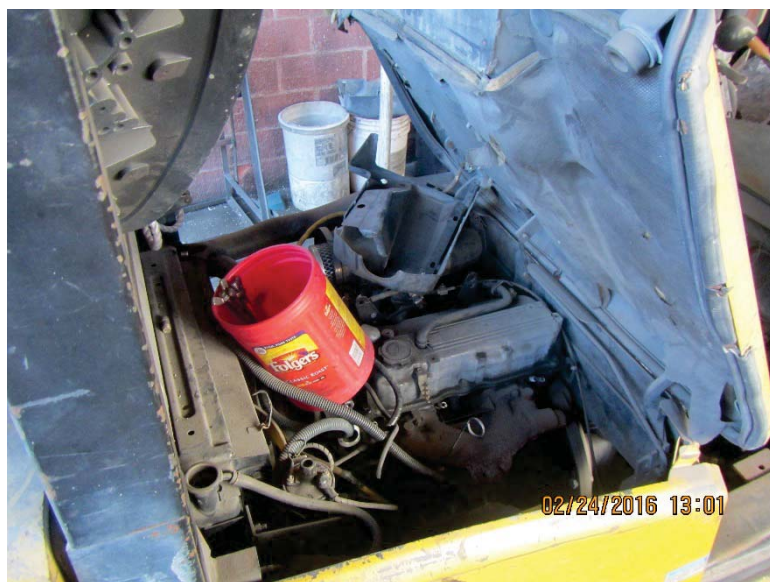
IMG\_0009.JPG. Zoomed in Engine of forklift from Image 0008 being worked on.

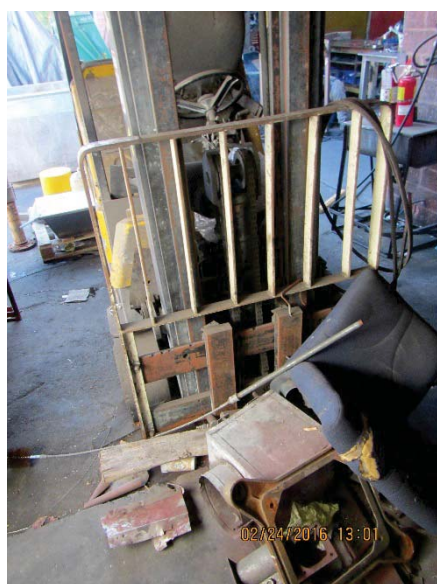
IMG\_0010.JPG. Front side of forklift from Image 0008, adjacent to northeast shipping/receiving dock.

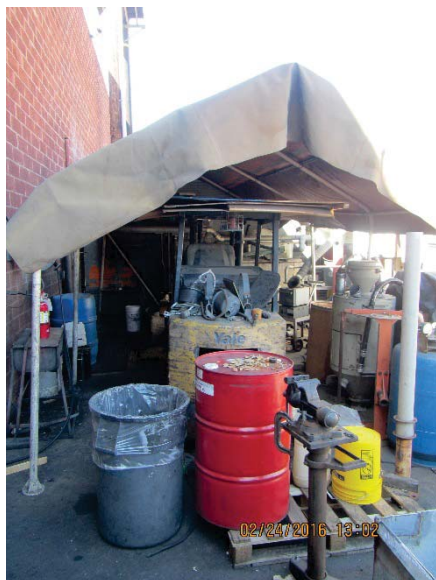
IMG\_0011.JPG. Front side angle of forklift from Image 0008.

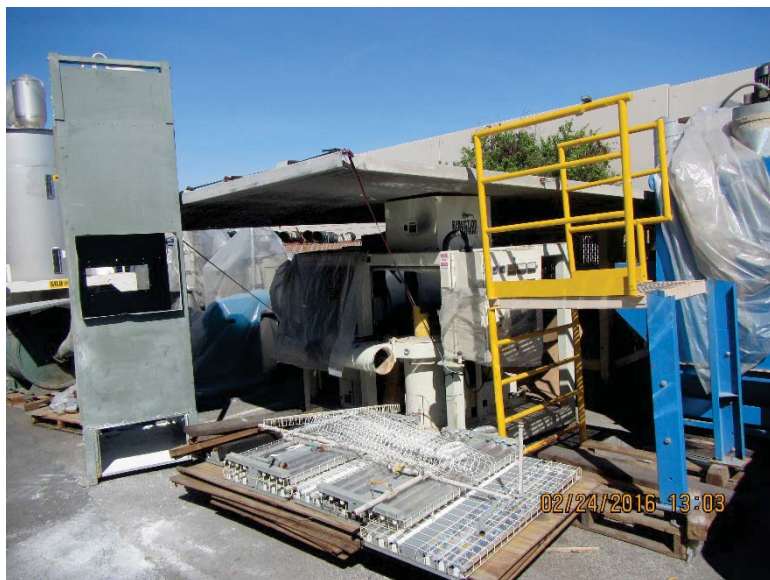
IMG\_0013.JPG. Northeastern view of material stored outside in parking lot. Note unidentified white powder on impervious surface.

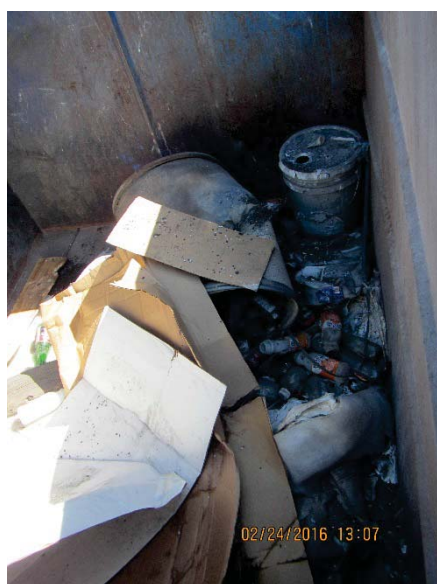
IMG\_0018.JPG. Inside view of dumpster located outside in the northeastern portion of the facility grounds. Note the loose plastic fragments.

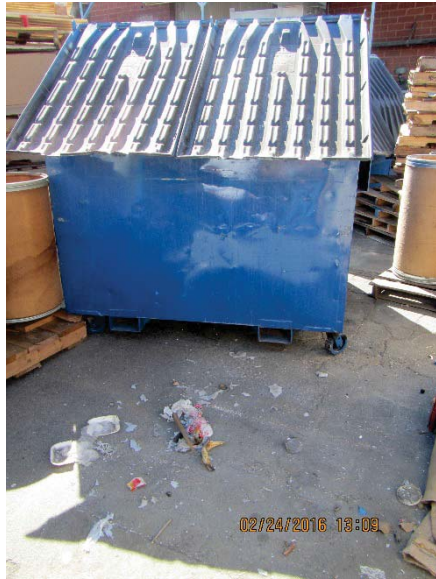
IMG\_0019.JPG. Back view of the dumpster from Image 0018. Note the scattered plastic fragments and plastic debris scatted on impervious payment.

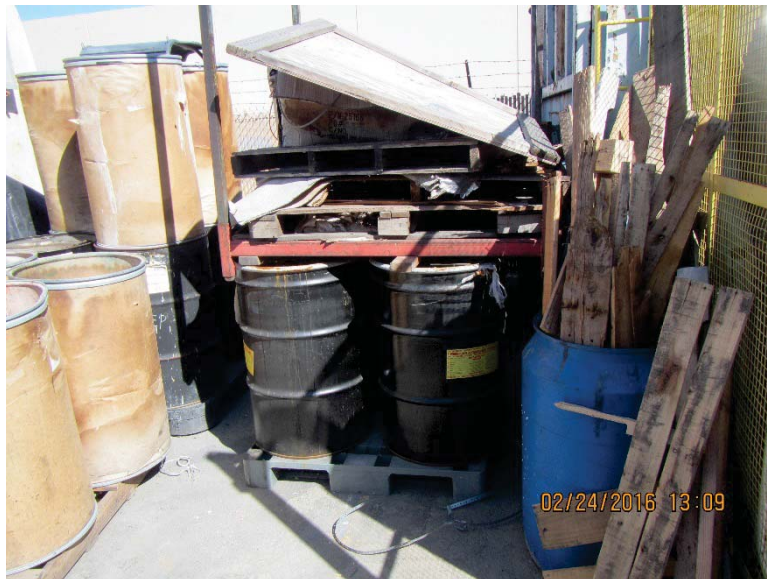
I observed that the SWPPP lacked a Monitoring Program. The Monitoring Implementation Plan (MIP) requirement is specified by Section X.I. of the Permit. The MIP must be included in the SWPPP and should include discharge locations, visual observation procedures, instrument calibration requirements and a sample chain-of-custody to be used when transporting samples to the lab. Additionally, the SWPPP states “Modern Concepts maintains [sic] a current Contingency and Emergency Preparedness Plan in case of a [sic] hazardous material spill.” However, Mr. Warpack stated that no such plan was ever written, and also said was not needed because little to no hazardous waste was handled on site. Later however, during the closing conference, I referenced my site-walk through and said I did see barrels labeled as hazardous (see Attachment A; Images 0020).

IMG\_0020.JPG. Barrels of material marked as hazardous stored outside in northeast corner of parking lot.

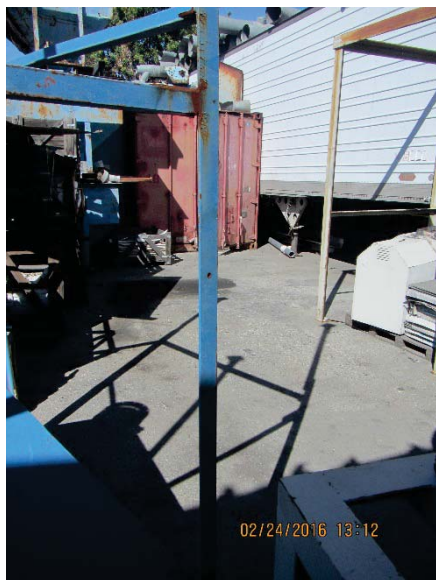
IMG\_0023.JPG. Northwest corner of facility. Note scatted plastic pellets on impervious surface.

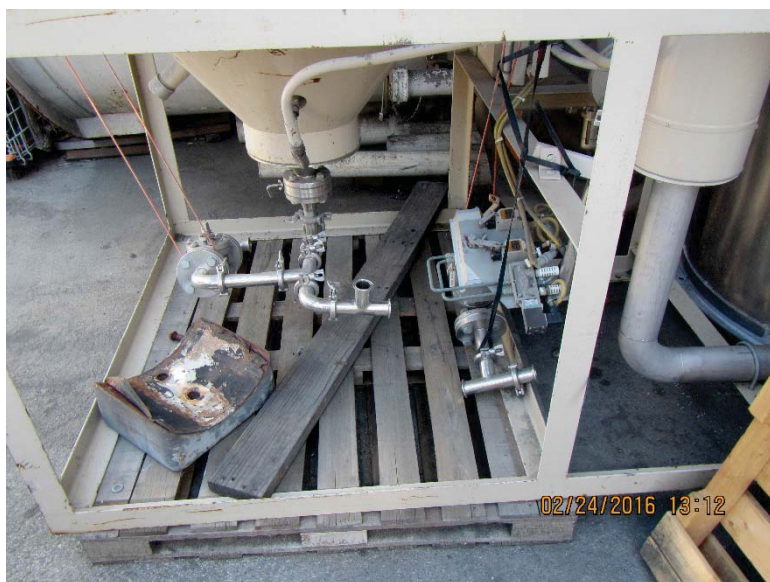
IMG\_0024.JPG. Plastic pellet transfer silo. Note plastic pellets on impervious surface.

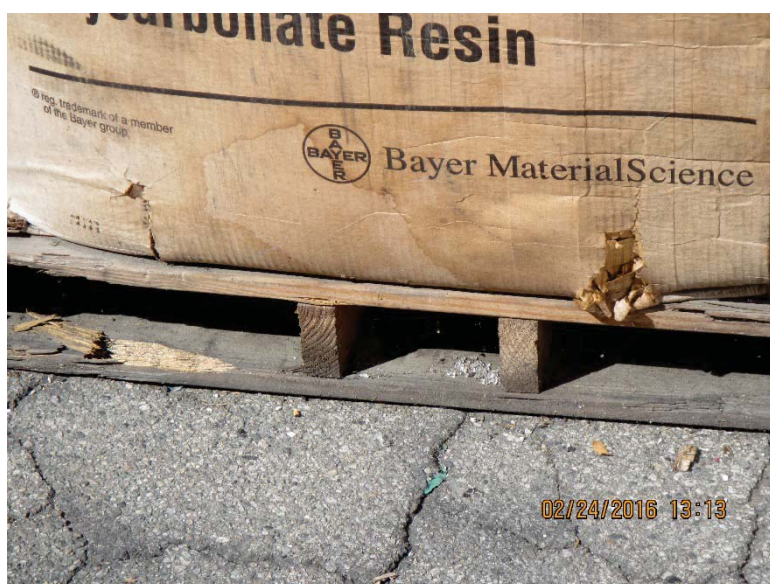
<b>Durable sealed containers at loading / unloading / transfer/ storage areas</b>	<b>No</b>	Durable sealed containers were not observed onsite. Images 0026 – 0031 of the photo log shown multiple leaking super sacks and loose plastic resin pellets in and around the dumpster. See also Images 0018 – 0019.
<b>Form of secondary containment at loading / unloading / transfer / storage areas</b>	<b>No</b>	No catchment devices as a form of secondary containment were observed.
<b>Vacuum system(s) available?</b>	<b>No</b>	Plastic resin pellets are transferred using an indoor vacuum system. However, no vacuum-type system for quick cleanup of fugitive pellets was observed.
<b>Containment system or alternative for plastics materials &lt; 1mm in size</b>	<b>NA</b>	No containment system designed to trap plastics less than 1 mm in size were developed. Images 0041 – 0042, 0044, and 0046 – 0048 of the photo log do not show a complete containment system. Additionally Images 0050 and 0052 show storm drains clogged with sediment and cannot capture plastic pellets.

IMG\_0026.JPG. Zoomed in leaking super sack storage box of plastic pellets.

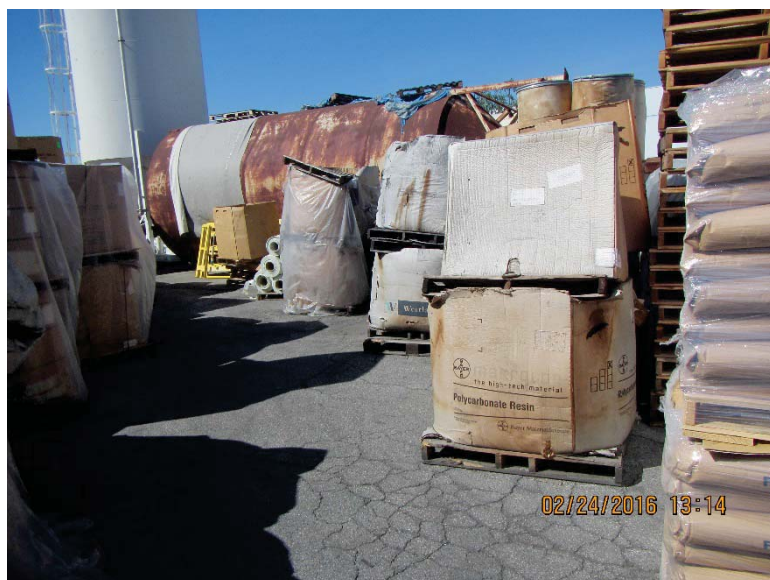
IMG\_0027.JPG. Zoomed out leaking super sack storage box of plastic pellets from image 0026 in silo storage area.

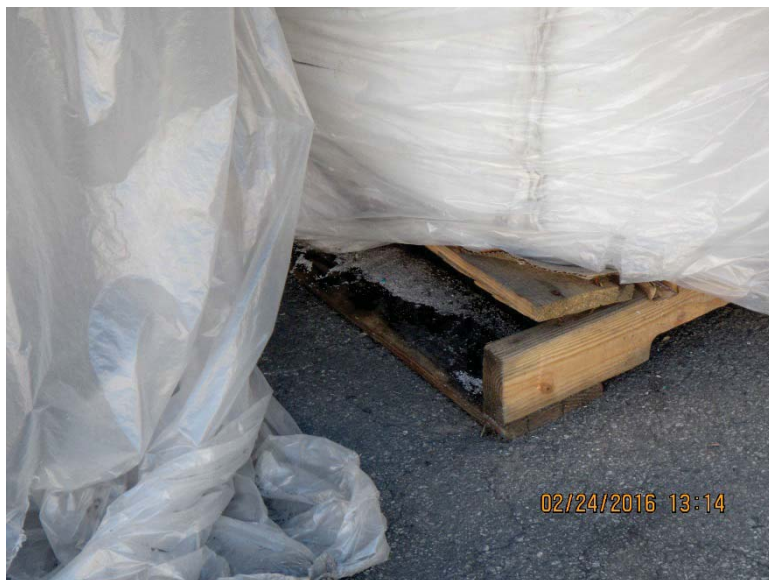
IMG\_0029.JPG. Zoomed in image of leaking storage containers of plastic pellets from image 0028.

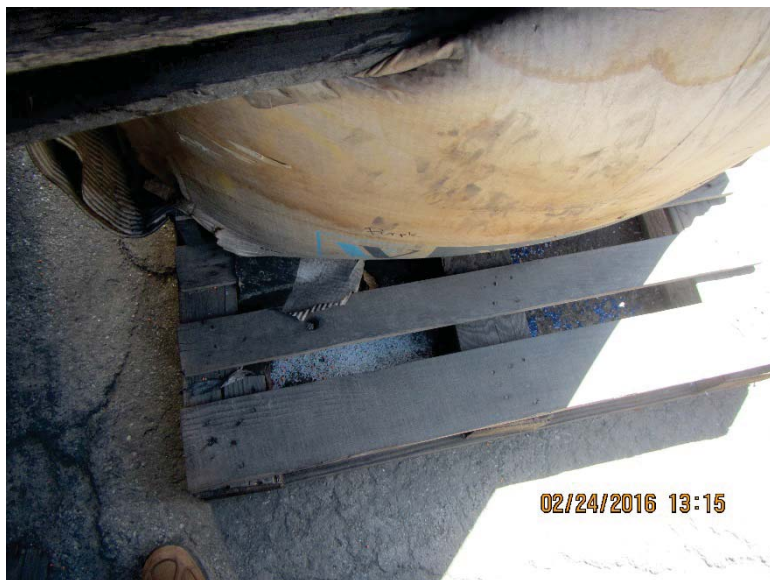
IMG\_0031.JPG. Zoomed in image of storage containers outside leaking plastic pellets from Image 0030.

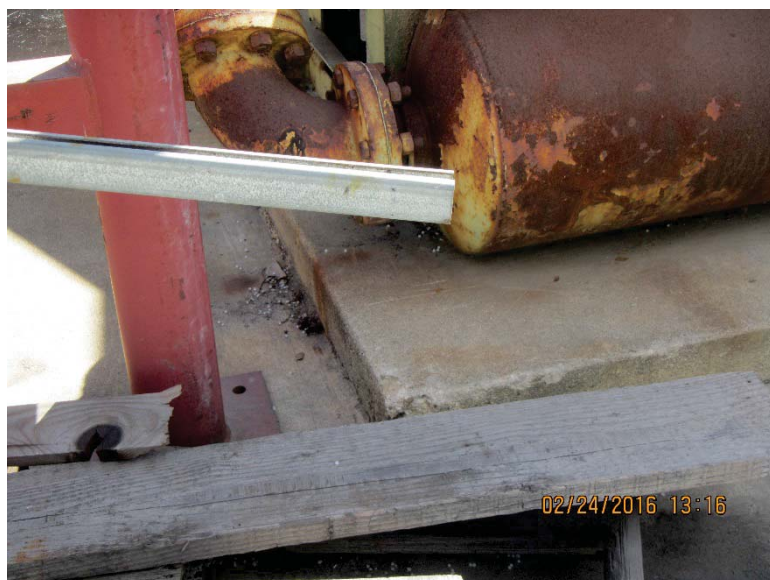
1. I observed, at the time of the inspection, scattered polystyrene resin plastic pellets on the impervious surfaces exposed to wind dispersion and storm water runoff located around the backyard and silo storage area (see Images 0032 – 0036) and around the Facility dumpster at the north end of the parking lot (see Images 0018 – 0019). Additionally, I observed scattered pellets on impervious surface areas from leaking super sacks and storage containers at and around the backyard and silo storage area (Images 0026 – 0031). The dumpster, backyard and silo storage areas are upgradient of the storm water trench that flows north to south through the parking lot (Images 006, 007, and 0053) before discharging out the parking lot entrance via Main Drain Discharge A. Section X.H.1.a.i and Section X.H.1.a.vi, Good Housekeeping Minimum BMPs, of the Permit, states the Facility shall observe, identify, clean, and properly dispose of industrial materials, debris, and waste and contain all materials or wastes from wind dispersion and storm water contact. The SWPPP makes no mention of plastic materials that may discharge offsite to be cleaned up in a timely manner.

IMG\_0033.JPG. Zoomed in plastic pellets outside in silo storage area from Image 0032.

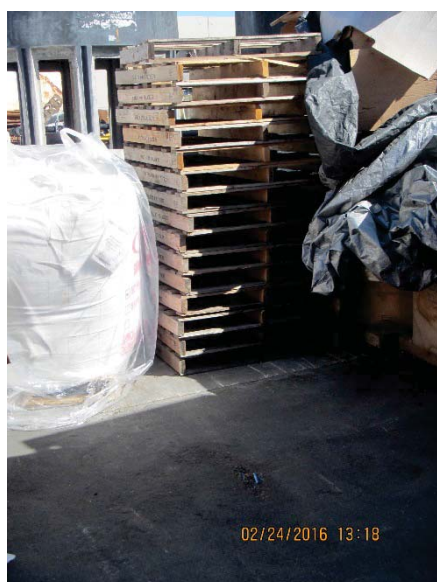
IMG\_0034.JPG. Background image of debris on impervious surface in silo storage area.

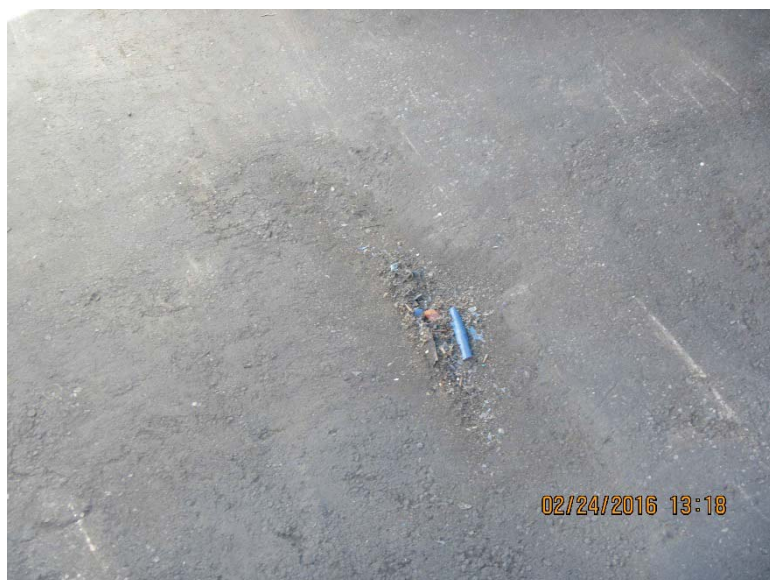
IMG\_0035.JPG. Zoomed in debris on impervious surface in silo storage area from Image 0034.

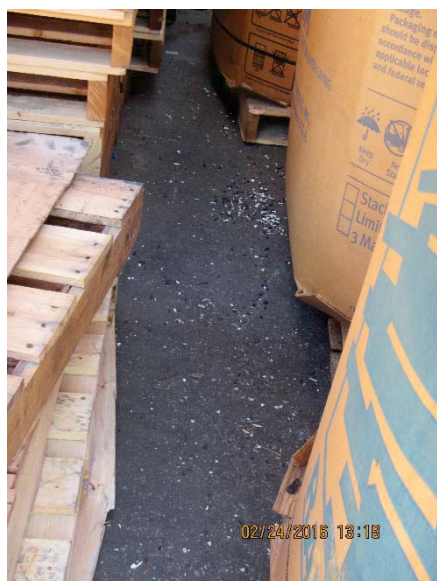
IMG\_0036.JPG. Plastic fragments on impervious surface adjacent to super sack storage boxes outside in silo storage area.

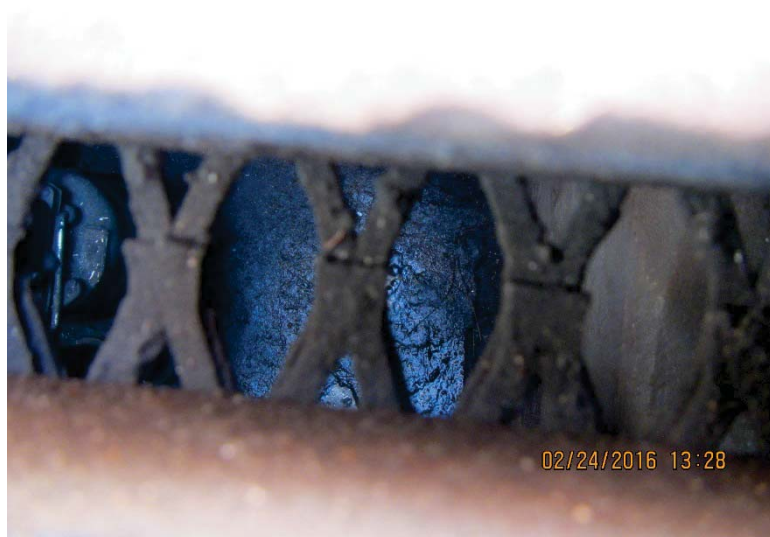
IMG\_0046.JPG. Additional interior shot of Sump Pump Discharge B drain from Image 0041. Note inconsistent metal mesh from Image 0042.

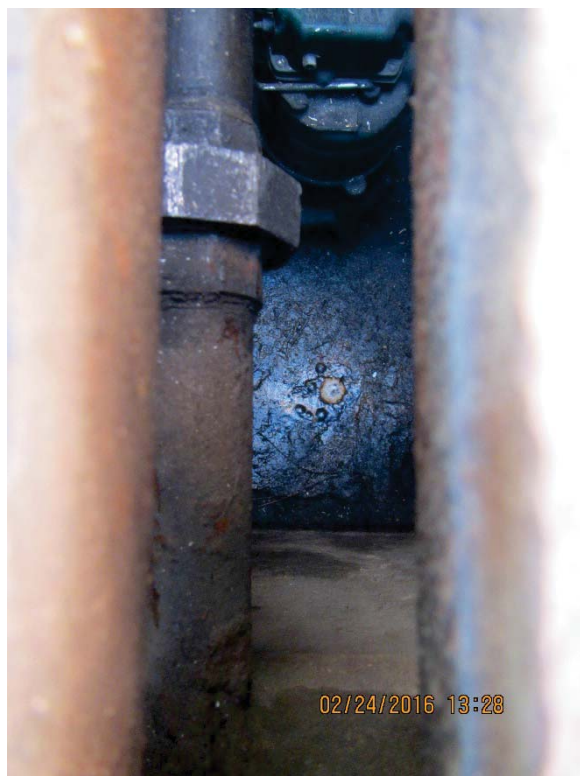
IMG\_0047.JPG. Additional interior shot of Sump Pump Discharge B drain from Image 0041. Note lack of uniform metal mesh from Images 0042 and 0046.

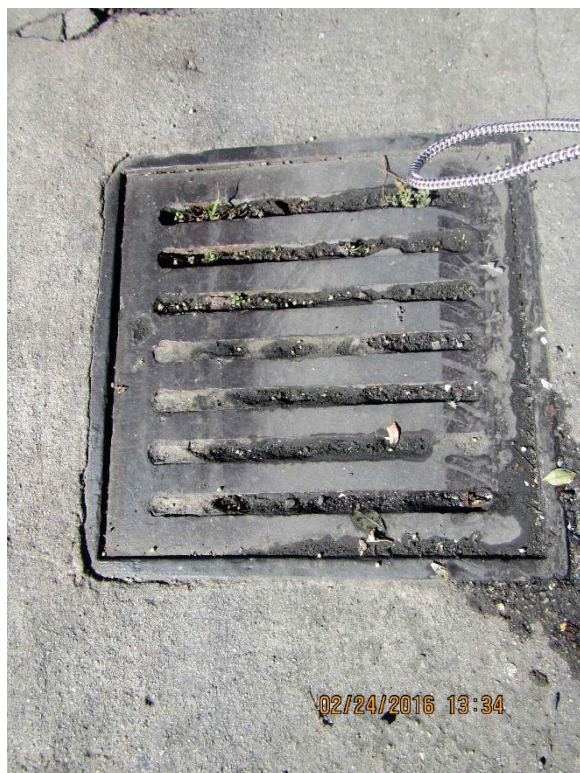
IMG\_0052.JPG. Zoomed in Main Drain Discharge A drain clogged with sediment from Image 0050.
